Time Period:	November of two w	17-29, 2014 (eeks)	Project No:	1305
Rain Days/Weather Conditions:		Rained 1.6" on Sunday night-Monday morning (11/16-11/17). Also rained 0.75" Monday (11/23) (Burkesville gauge).		
Personnel on-site:  Equipment on-site:		EcoGro/Ridgewater: Tony Berry, Tom Cutter, Eric Dawalt, Jon Linder, Brad Redmon, & Chad Relinski.  Stantec: N/A  Komatsu PC 160 w/ hyd. thumb, PC 360 w/ hyd. thumb, Terex TA27		
		articulating dump truck, Bobcat T300 skid steer, Sunbelt JCB pad foot compactor (demobilized on 11/25), & Morooka 2200 VD Tracked Dump Truck		
Material deliveries to project site:		■ N/A		
Work performed the past two weeks:		<ul> <li>Did not work Monday(11/17) or Monday (11/24) due to rain.</li> <li>Moved all tree piles off of Corps Site #1.</li> <li>Started construction of braided channel RT Sta. 111+00 to 113+00.</li> <li>Hauled rock from Disposal area and stockpiled at ~Sta. 114+00 for channel construction.</li> <li>Excavated for floodplain and channel upstream of Campground Road (~Sta. 113+00 to 114+00) and hauled clay to ravine.</li> <li>Built ravine compacted clay fill up to ~elevation 586.0'.</li> <li>Built rock spillway up to ~elevation 583.5'</li> <

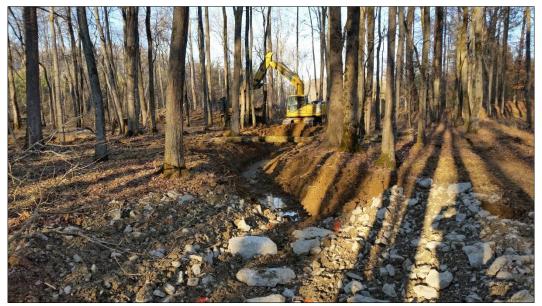
Constructing braided channel . (Photograph taken from ~RT Sta. 111+50)

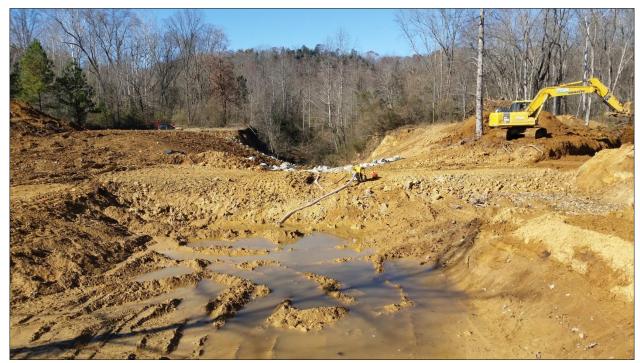
Finished construction of compacted ravine clay core to elevation ~586.0' (Photograph taken from Ravine Footbridge)

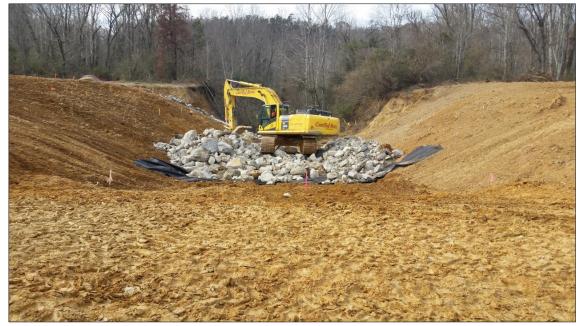
Constructing ravine rock spillway with geotextile and rock (Photograph taken from ravine compacted clay core).

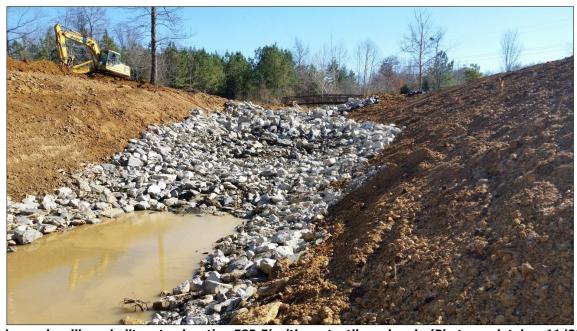
Ravine rock spillway built up to elevation 583.5' with geotextile and rock. (Photograph taken 11/22 at ~180' LT Sta.106+30).

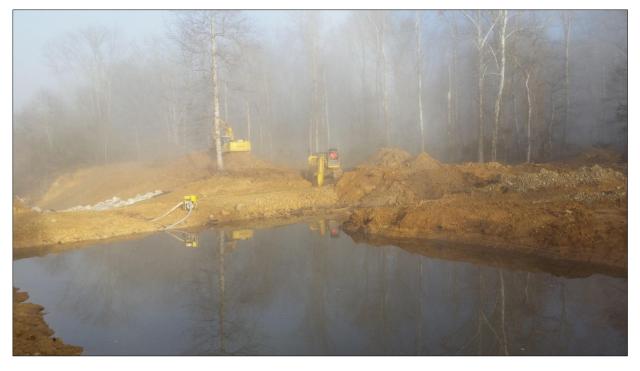
Constructing clay Ground Water Dam to bedrock from ~ LT. Sta. 106+60 to 107+80 (Photograph take from left end of ravine footbridge). Ponded water is in ravine.

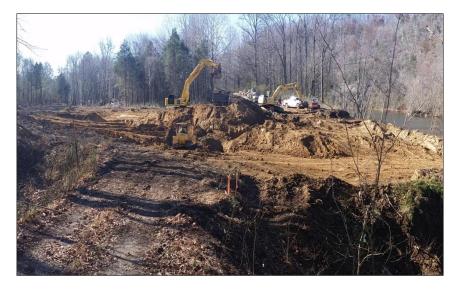
Aspen Construction excavating from Site #3. (Photograph was taken from existing gravel road at ~Sta. 157+50 looking upstream).
